Manhole Inspection Summary

Manhole # S11CC2057MH

Location Address: **5738 GREENSPRING AVE**

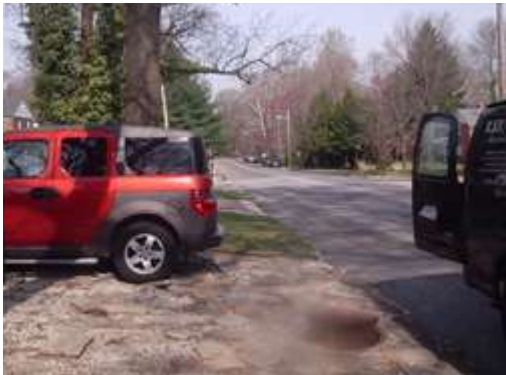
Location View

Comments **IN GRAVEL DRIVEWAY IN FRONT OF 5738 GREENSPRING AVE**

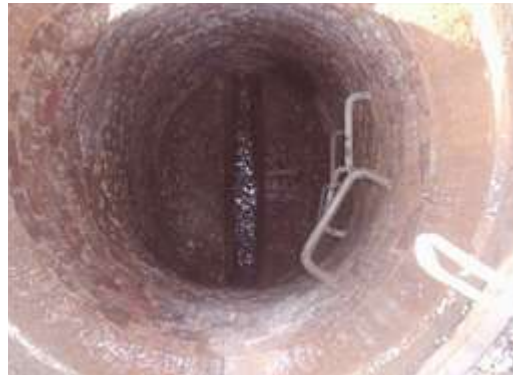
Top View

Frame leaks. Barrel infiltration. Evidence of surcharge - Bench debris. Channel debris.

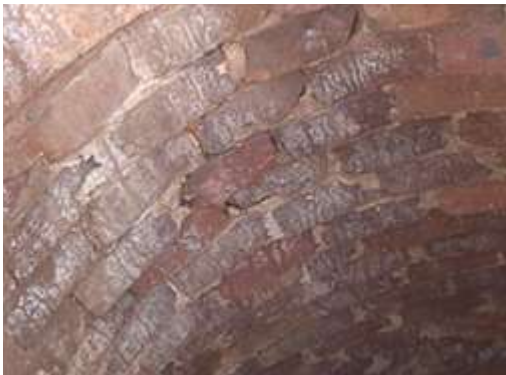
Defect

Condition: ☐ Sound ☐ Cracked ☐ Root Intrusion ☐ Loose Brick ☒ **Deteriorated**

Infiltration: ☐ None ☒ **Joint** ☐ Cracks ☒ **Mortar** ☐ Roots ☐ Wall

Corbel deterioration and infiltration.

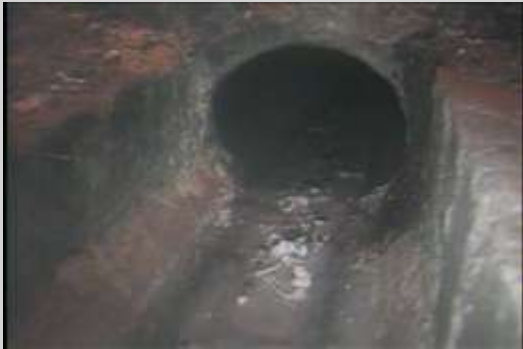
8 in. Circular Gravity Sewer Pipe Out @ 12 O'Clock

Deposits: ☐ None ☒ **Mud** ☐ Sludge ☒ **Debris** ☐ Grease

Silt Depth: **0** (in.) Deposits Extent: **Light**

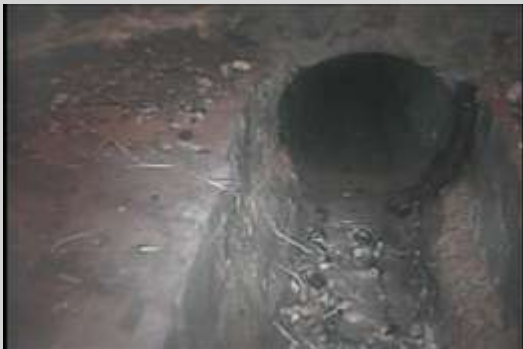
8 in. Circular Gravity Sewer Pipe In @ 6 O'Clock

Infiltration: **Evidence** Pipe Seal Cond: **Cracked**
